Associated Inspectors, Inc.

SUMMARY REPORT

Client: Joanne Liu
Realtor: Dale Rowse, Remax Central
Inspection Address: 4557 Sirius Ave., Las Vegas , NV 89102
Inspection Date: 2/3/2009
Inspected by: Greg Pastuch

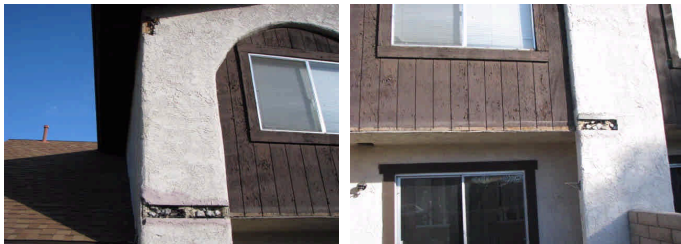
The voids in the stucco left after removing the patio cover should be patched and repainted. Filling the voids with another type of patio cover needs HOA approval there are wood boring resistant materials available one type is referred to as "Alumawood" The section up top near the roof needs patching.

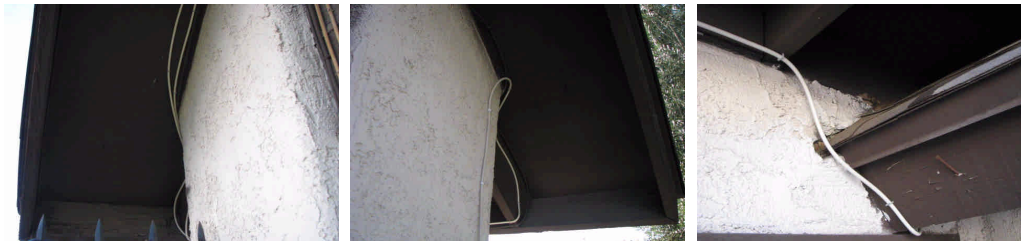
Sections of the fascia and trim need maintenance type service, Painting and refinishing. Particularly on the south facing side where they are exposed to direct sunlight.

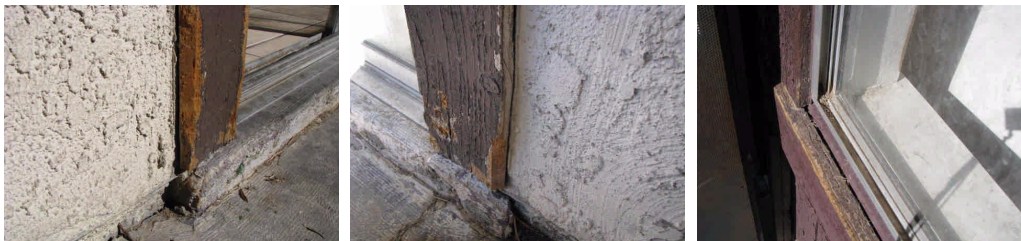
The decorative wood trim has separated from the house walls, and should be serviced to forestall further deterioration.

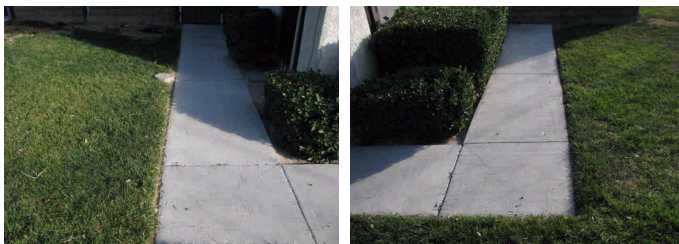
The walkways are concrete and appear to be in serviceable condition

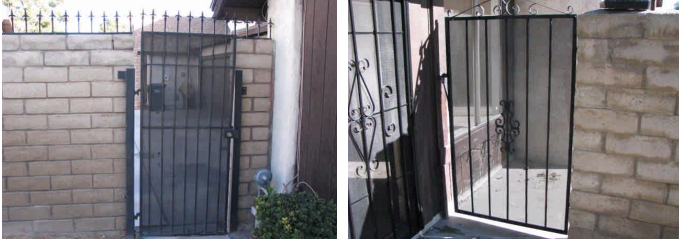
The fences and gates appear to be serviceable. The side yard gate is pad locked we did not test it, although it does appear to be serviceable.

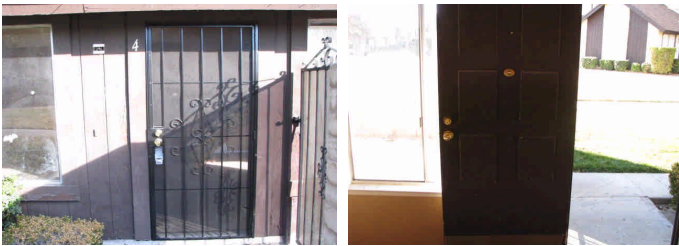
The exterior door appears to be serviceable

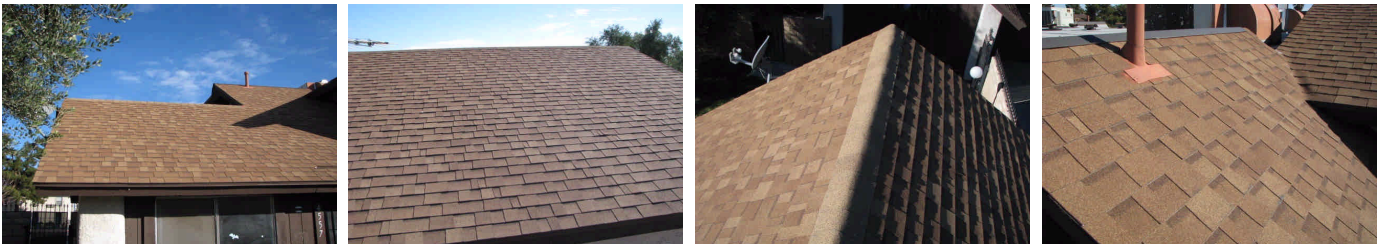
We evaluated the roof and its components by walking on its surface.

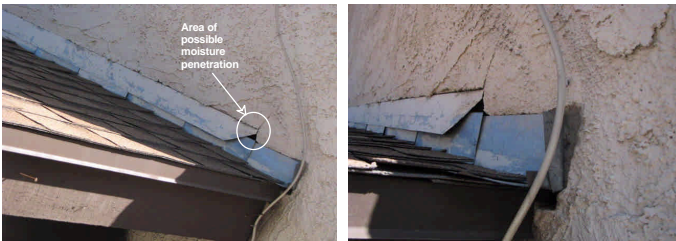
There appears to be an improper termination of flashing. Correction is needed for proper runoff of water or to protect from any moisture penetrating the side of the home.

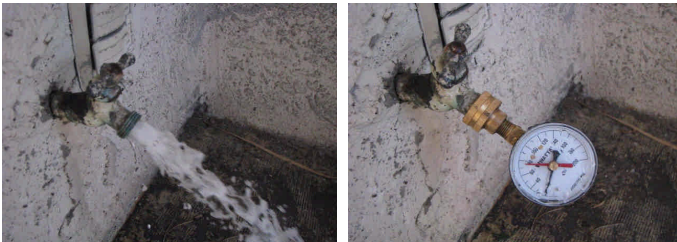
A water pressure test was conducted at the hose faucet we got a reading of 80 psi which is the maximum acceptable level.

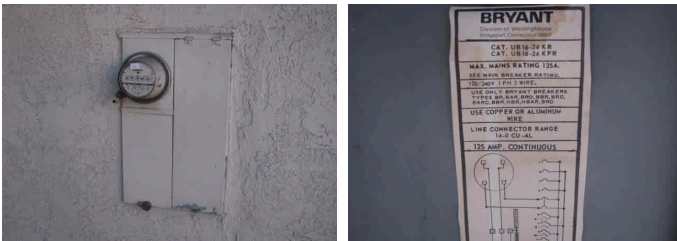
The residence is served by a 125 amp, 240 volt rated panel, located in the garage side yard.

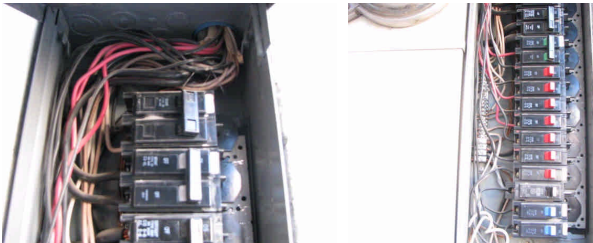
The visible portions of the wiring appear to be serviceable.

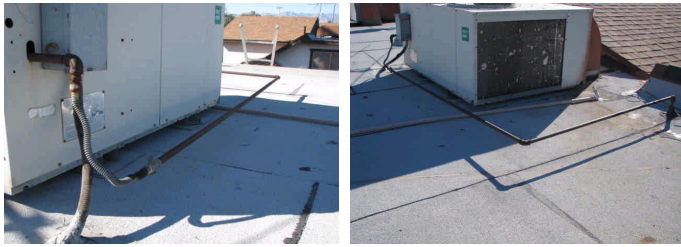
The gas supply line is unsupported from the roof penetration to the flex line attached to the unit, this is a unsafe condition and needs service to avoid any stress to the supply line and further consequences this could result in a leak and would be difficult to detect due to the location on the roof.

The gas supply line is unsupported from the roof penetration to the flex line attached to the unit - *Continued*

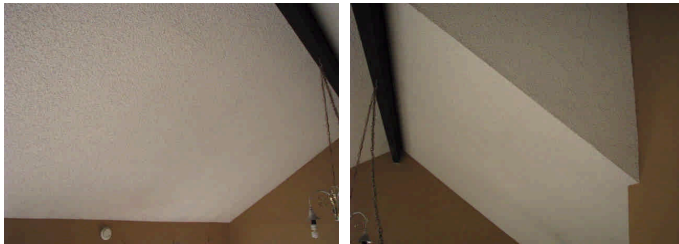
The ceiling appear to be in serviceable condition which may include common cracking (cosmetic damage).

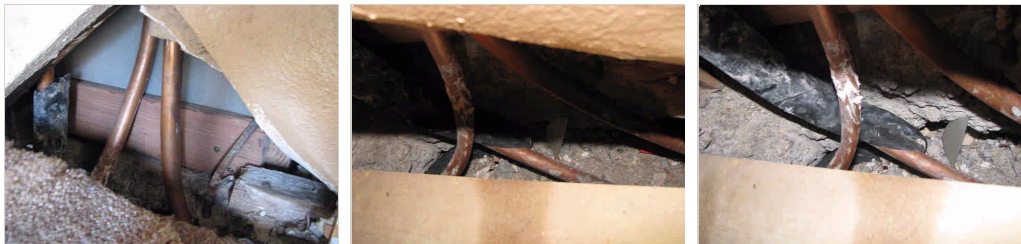
There is a repair access hole noted on the wall. This was discovered hiding behind the pegboard after it was removed there was previous repair done to the water supply lines in the wall. This appears to have been done correctly the only issue is the wall is suppose to be sealed back up with drywall and paint.

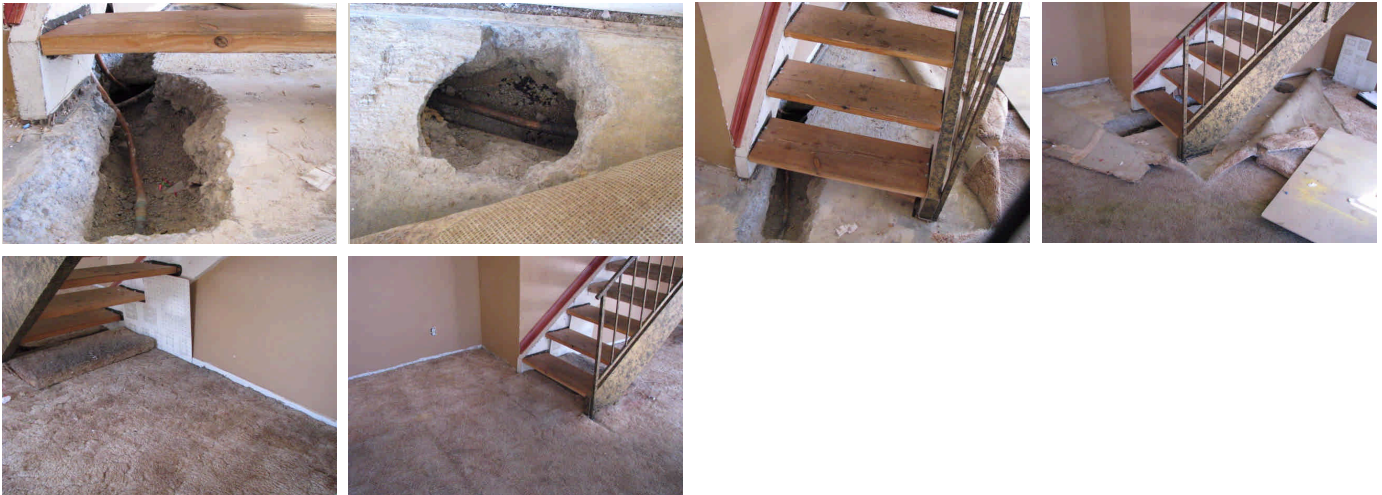
The carpet under the steps was pulled back and revealed more repair to the water supply lines. Again this appears to be serviceable the issue is the work is not complete because the floor has not been resealed. We recommend further evaluation by a licensed professional prior to back filling.

The carpet under the steps was pulled back and revealed more repair to the water supply lines - *Continued*

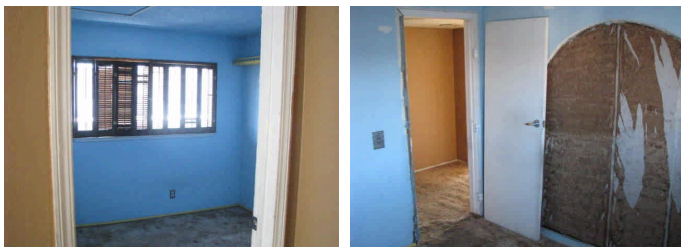
All components of the loft appear serviceable except as noted below. This is a converted space made up to be a additional bedroom. This room has no closet that is why it is categorized as a loft.

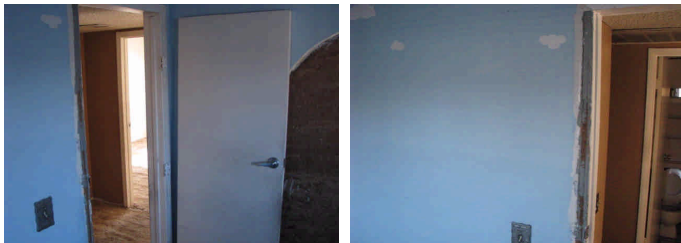
The door is off its hinges in the loft

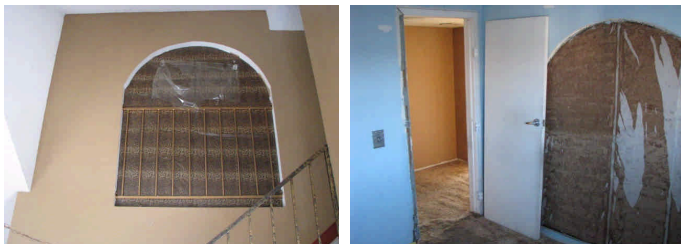
Prior patch and repair was noted on the walls and/or ceiling which you may wish to have verified by the seller. This was a arch for the loft that has been sealed off for privacy.

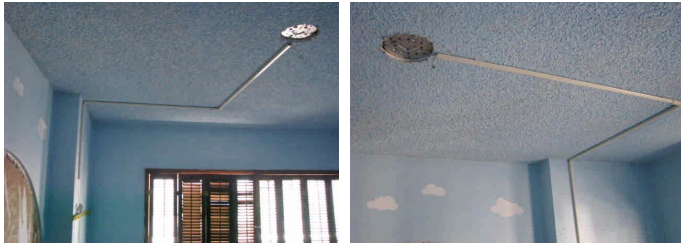
The ceiling fixture should be upgraded to have its own electrical outlet

The ceiling fixture should be upgraded to have its own electrical outlet - *Continued*

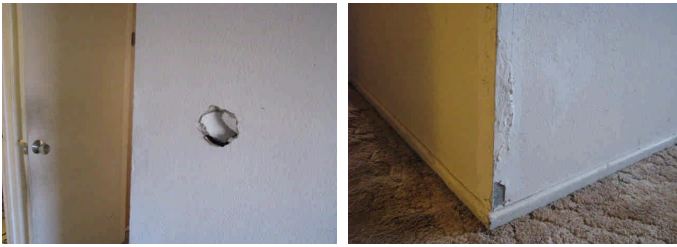
There is a hole noted in the wall, and there is also damage and previous attempted repair to the corner below.

There is a hole noted in the wall - *Continued*

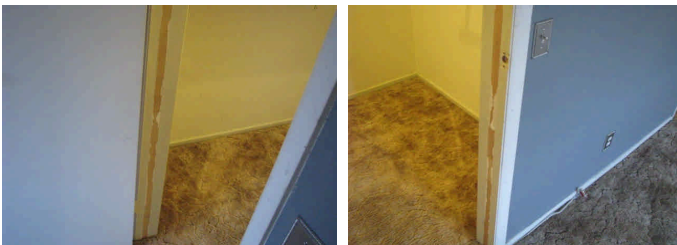
The door jam is incomplete

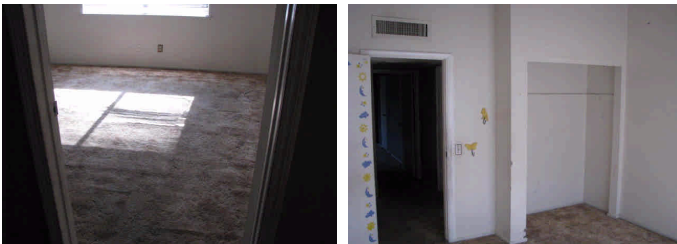
All components of the second bedroom appear serviceable unless noted below

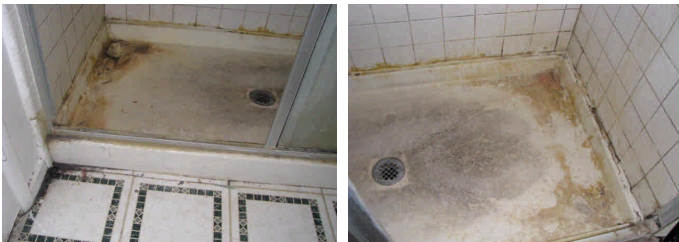
There appears to be a mildew or mold-like substance at the stall shower area which should be evaluated. It is suggested to have complete testing done to confirm the type of substance present and make complete thorough corrections as needed, as we are per Nevada State Law unable to dismantle, lift, or determine for ourselves what the substance is.

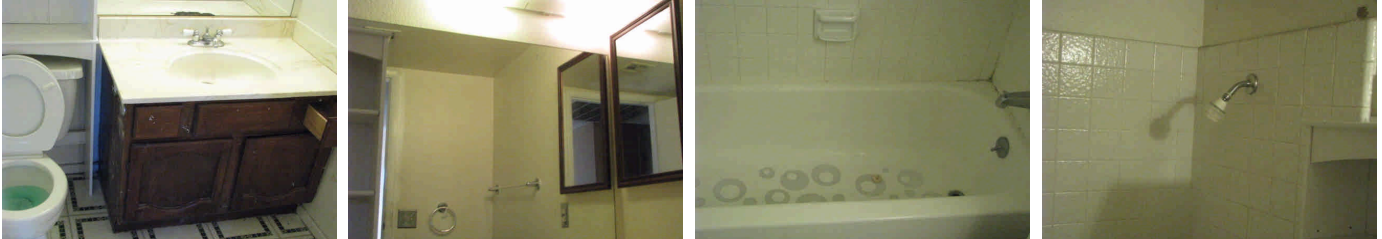
All components of the hallway bathroom upstairs are operational unless noted below

Caulk needed in various seams around the counter floor and walls

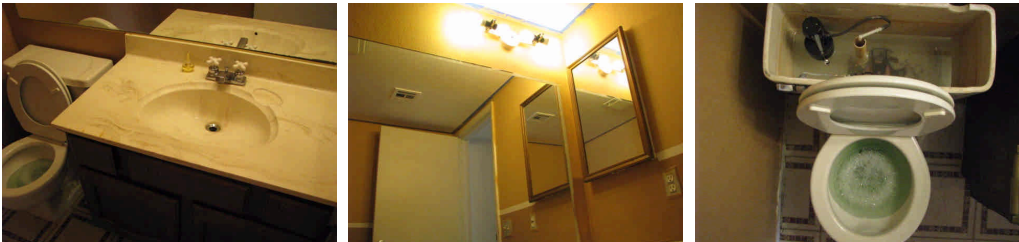
All components of the half bathroom are operational unless noted below

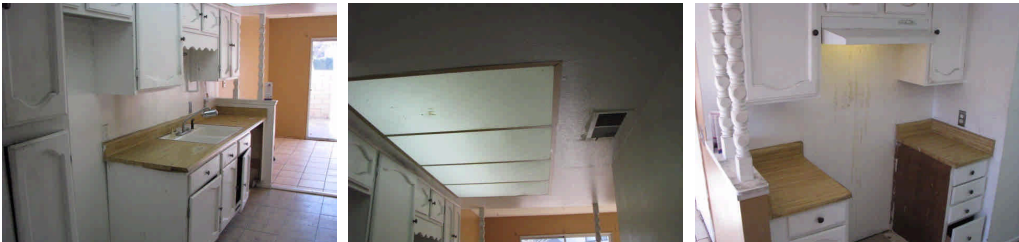
All components in the kitchen appear serviceable unless noted below

It was noted that all of the appliances were missing at the time of the inspection.

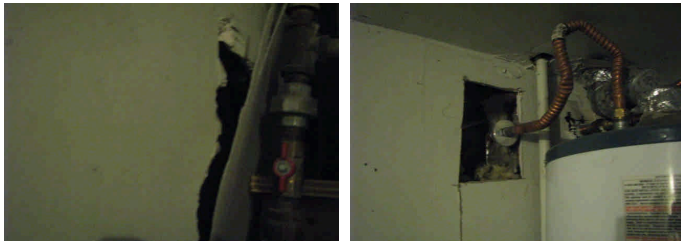
The voids in the garage wall need to be repaired by the water heater
